PEDESTRIAN AUDIT: ½ MILE SEGEMENT ANALYSIS

Segment Location: Virginia Avenue – Gaston Edwards Park Date: July 10, 2011

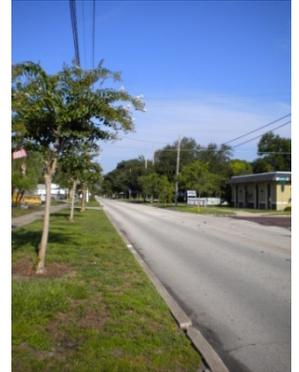
Score 5

Sidewalks on both sides of Virginia Avenue

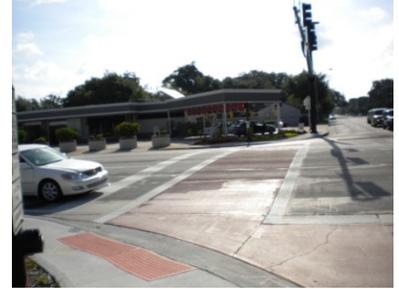
Score 4

Major intersections signalized and marked, textured cross walks provide visual and tactile indication of pedestrian movement for vehicle drivers in the area. Lack of midblock crossings creates of feeling of urgency when attempting to move freely within the pedestrian shed.

The addition of mid-block crossing between the two commercial blocks would encourage wandering and exploring the area. Although some placemaking signage is provided, an integrated wayfinding theme and more active store fronts would improve this trek to Gaston Edwards Park.

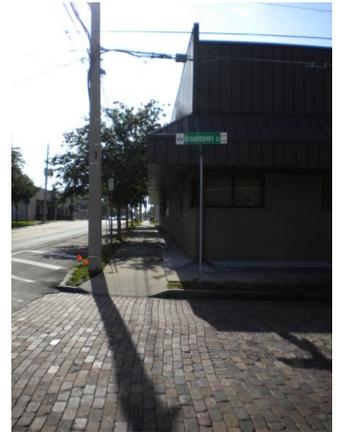
Score – 5 –Pedestrian shed in this route has less engineered crossings as it is more suburban in nature. There were no instances of cracked concrete or loose bricks along the path.

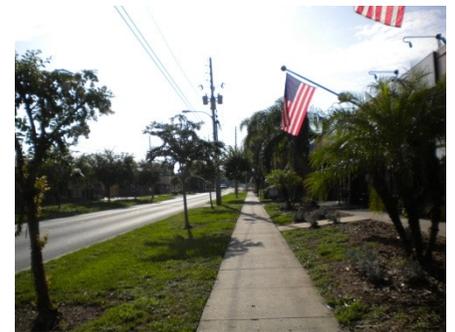
Score 5

Large buffer area between the road and the pedestrian path provided on both sides of Virginia Avenue

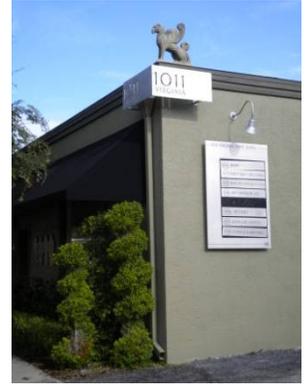
Score 4

Some of the storefronts along the route offer eclectic details of interest. The businesses closer to the rail line provide warehouse fronts, minimal landscaping or other elements to improve the quality of the pedestrian experience.

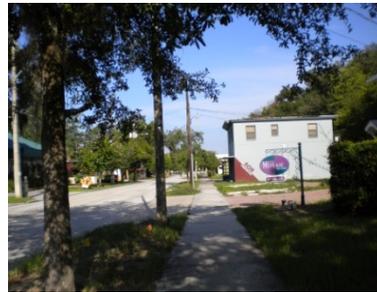
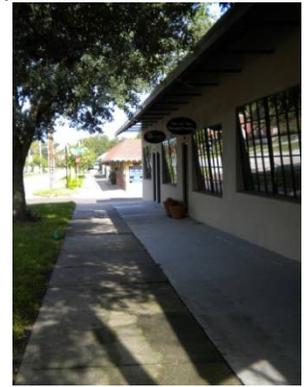
Score 4

Shade is provided either by landscaping or by architectural features.
