# PEDESTRIAN AUDIT: ½ MILE SEGMENT ANALYSIS

Location: Christo Café (Described as the ‘Best Breakfast spot in College Park’) to Princeton Park

Date: July 21, 2011 By John Chenoweth

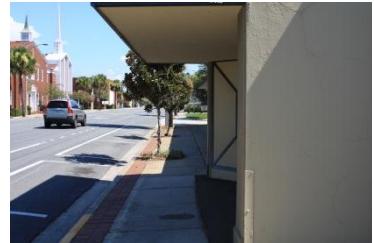
**1. Pedestrian Facilities (High):** presence of a suitable walking surface, such as a sidewalk or path.

- 1 No permanent facilities; pedestrians walk in roadway or on dirt path
- 2
- 3 Sidewalk on one side of road; minor discontinuities that present no real obstacle to passage
- 4
- 5 Continuous sidewalks on both sides of road.**

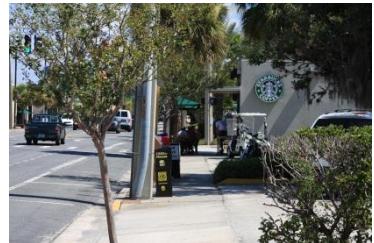
**2. Pedestrian Conflicts (High):** potential for conflict with motor vehicle traffic due to driveway and loading dock crossings, speed and volume of traffic, large intersections, low pedestrian visibility.

- 1 High conflict potential
- 2
- 3 There is one busy street to cross, but a clearly marked cross walk exists with push buttons that allow pedestrians to interrupt traffic. Most intersections have faded crosswalks.**
- 4.
- 5 Low conflict potential

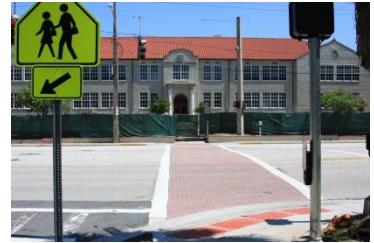
**3. Crosswalks (High):** presence and visibility of crosswalks on roads intersecting the segment. Traffic signals meet pedestrian needs with separate ‘walk’ lights that provide sufficient crossing time.

- 1 Crosswalks not present despite major intersections
- 2
- 3
- 4 Crosswalks and crossing signals exist in the streets connecting to Edgewater Drive. Crossing streets intersecting Princeton can be of concern as drivers may not be aware of pedestrians.**
- 5

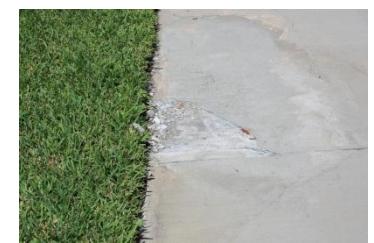
**4. Maintenance (Medium):** cracking, buckling, overgrown vegetation, standing water, etc. on or near walking path. Does not include temporary deficiencies likely to soon be resolved (e.g. tall grass).

- 1 Major or frequent problems
- 2
- 3
- 4
- 5 The sidewalks are generally in good condition for the full length of this segment. Some recent repairs are evident**
