PEDESTRIAN AUDIT: ½ MILE SEGEMENT ANALYSIS

Segment Location: Eatonville Town Hall to Eatonville Community Center

Date: Sunday, July 8, 2012

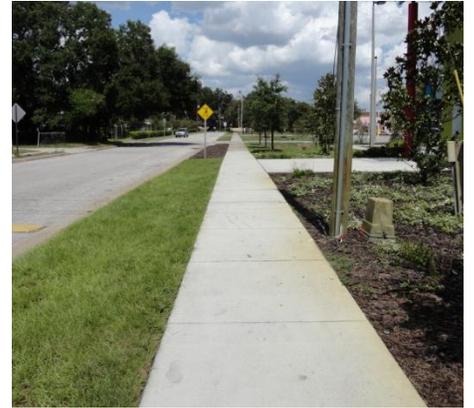
1. Pedestrian Facilities (High): presence of a suitable walking surface, such as a sidewalk or path.

3 There is a continuous side walk on this segment with signage at some intersections. The sidewalk is only wide enough for one adult to walk down it.

There are many improvements that would enhance this route. First, there is a substantial need for shade, but the landscape buffer necessary for the healthy growth of large shade trees is not present. These buffers should be increased. The sidewalks on this segment should also be widened, especially because this route contains major destinations like city hall, the local elementary school, the local Boys and Girls Club branch, and the Eatonville Community Center.

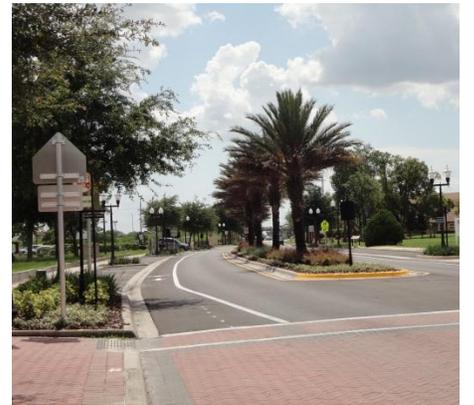
2. Pedestrian Conflicts (High): potential for conflict with motor vehicle traffic due to driveway and loading dock crossings, speed and volume of traffic, large intersections, low pedestrian visibility.

4 There are some driveways that cut the sidewalk, but they are all to residential, single-family homes. Traffic volume is very low to moderate. There is only one major intersection; is a boulevard (Kennedy Blvd.) and has a median where pedestrians can seek refuge.

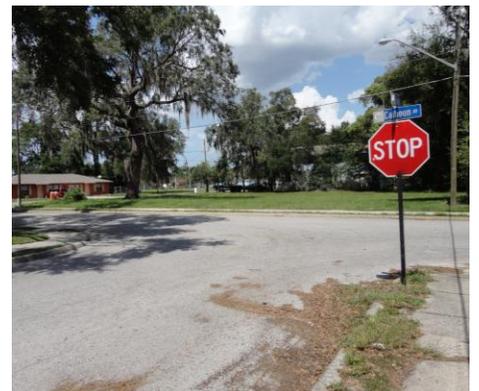
3. Crosswalks (High): presence and visibility of crosswalks on roads intersecting the segment. Traffic signals meet pedestrian needs with separate 'walk' lights that provide sufficient crossing time.

4 With the low volume of traffic, there is not much need for pedestrian signage, however there is signage at College and Kennedy. There should also be stop bars painted at stop signs

The major intersection at Kennedy and College is the most dangerous location on this route because of the relatively heavy traffic flow. Because of the size of the street, the crosswalk there should be widened to accommodate people crossing at different locations on Kennedy.

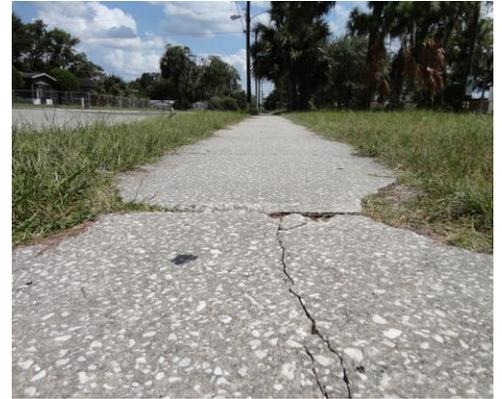
4. Maintenance (Medium): cracking, buckling, overgrown vegetation, standing water, etc. on or near walking path. Does not include temporary deficiencies likely to soon be resolved (e.g. tall grass).

1 Major or frequent problems: The sidewalks are in fair condition, however, throughout the entire segment there are empty lots with overgrown vegetation and rusted materials (cars, old play grounds, furniture, signs).

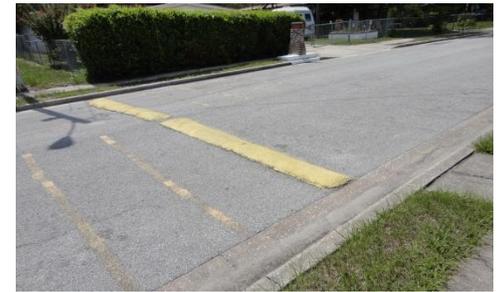
5. Buffer (Medium): space separating path from adjacent roadway.

3 The landscape buffer is less than 2ft. It is insufficient for shade trees, but does not contribute to pedestrians feeling less safe.

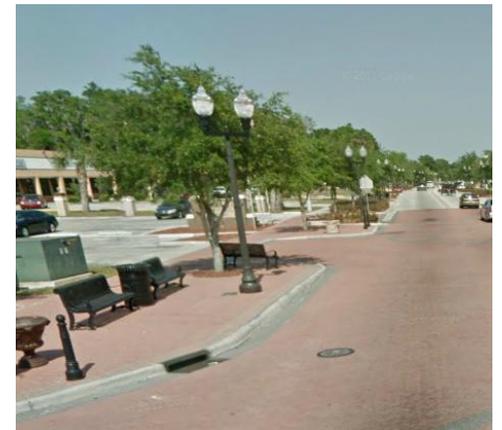
6. Aesthetics (Medium): includes proximity of construction zones, fences, buildings, noise pollution, quality of landscaping, and pedestrian-oriented features, such as benches and water fountains.

2 The quality of landscaping is poor throughout most of the segment. There are many empty lots and unkempt residential lots. There were no water fountains, even at the multiple community hubs on the route where the area has been redeveloped benches sat in direct sunlight.

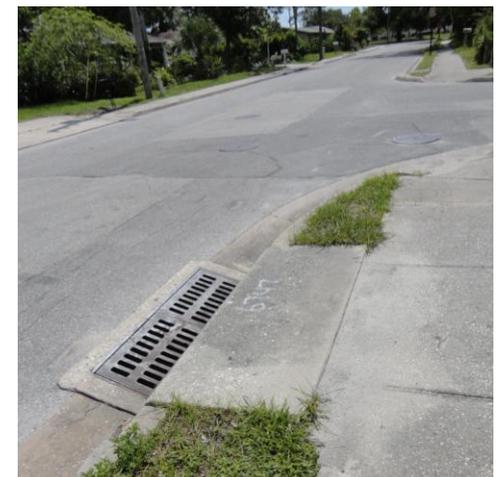
7. Shade (Medium): amount of shade, accounting for different times of day.

1 No shade: Pedestrians cannot walk this route in the heat summer. Nearly the entire segment is exposed to the sun. What few trees are on the route provide only seconds of relief from the sun.

The most unpleasant element of this segment is the severe lack of shade. It is a significant impediment to the utilization of this greenspace. The most pleasant features of this segment are its origin and destination points, which include many amenities in proximity of one another.
