AUDUBON PARK SITE ANALYSIS

PEDESTRIAN AUDIT: ½ MILE SEGEMENT ANALYSIS *from* AUDUBON PARK

Segment Location: Audubon Park – From Corrine Drive, by the Audubon Park Baseball Fields, by Brookshire West Elementary on Winter Park Drive/Virginia Avenue, down Asbury Avenue, and back to Corrine Drive via Cole Road and Christy Avenue

Date: July 6, 2013

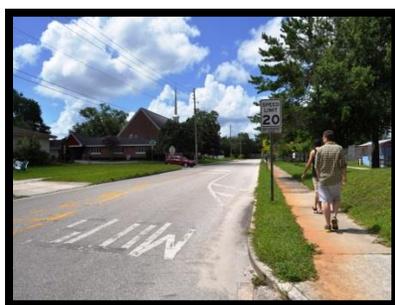
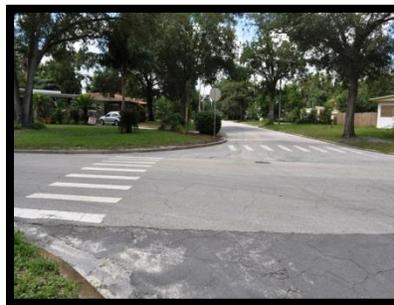
1. Pedestrian Facilities (High): presence of a suitable walking surface, such as a sidewalk or path.
 - 1 No permanent facilities; pedestrians walk in roadway or on dirt path
 - 2
 - 3 Sidewalk is only on one side of road; there were minor discontinuities but they present no real obstacle to passage. The entirety of the walk on Corrine, Winter Park Rd, and Virginia Drive had sidewalks on only one side of the street at a width of approximately 4'. This

negligence to only have pedestrian passage available on one side was evident even where one would rationally find high pedestrian traffic at Brookshire West Elementary School and the Audubon Park baseball fields. There were stretches of the road, notably where Corrine meets Cole, where there were no sidewalks, but this did not create an instance in which I felt uncomfortable to just walk in the rather wide street. At this intersection in particular it should be noted that even given the lack of sidewalks, crosswalks were still clearly painted on the street. Once in the more residential areas, although wide enough to safely allow for pedestrian use, cross streets in fact did not have any sidewalks. Intriguingly, there were portions of the road in which it appears that homeowners have taken the initiative to provide their own version of sidewalk, yet this is certainly intermittent and done with no semblance of safety in mind, making the attempt futile in my opinion. The curb was relatively short, providing little height. Finally, there were many portions of the walk where there was no green space provided between road and sidewalk, making vehicular traffic seem very close to designated pedestrian use.

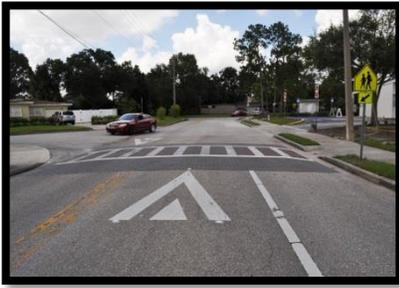
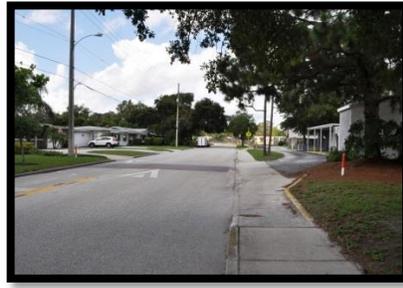
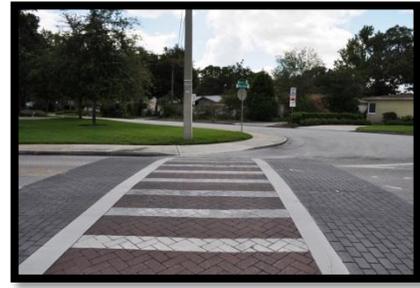
- 1 High conflict potential
 - 2
 - 3: Although there are very few buffers provided between automobile traffic and pedestrian use, the posted speed limit of 20-25mph was a clear deterrent against speeding. Additionally, no loading trucks are permitted to pass through the residential areas, as designated by large signs posted on the street once one turns off of Corrine Drive. Near both the school and church, there were some means of traffic calming supplied in the form of speed bumps as well as a great number of school crossing signs. Also worthy of note is that these speed bumps were constructed out of a dark brick which calls for their attention and certainly forces drivers to slow down. The greatest room for conflict would be at the vast number of entrances and exits at Brookshire West Elementary. It is noted that the number of entrances could be limited to create a less confusing, thus safer crossing environment.

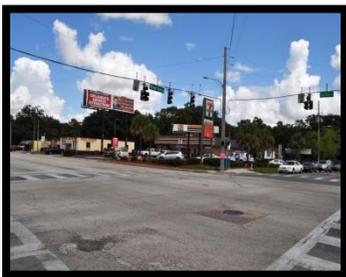
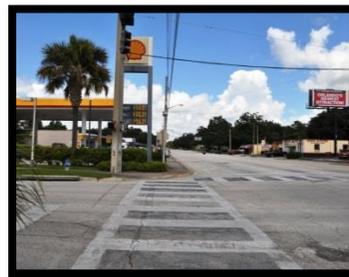
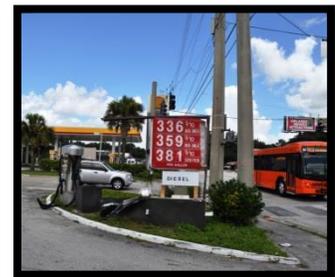
- 1 Crosswalks not present despite major intersections
- 2
- 3: There are adequate crossing light facilities provided at the intersection of Corrine and Winter Park Rd. which allow for sufficient crossing time. Intersections are clearly marked, although the sidewalk is not very wide, making wait time feel uncomfortable. At some points on Corrine, the sidewalk was pigeoned into smaller areas, providing an inadequate space for any more than one pedestrian to cross. Additionally, landscaping around these areas was sincerely decrepit as seen in the dilapidated gas price sign below. Paint is also in need of an update – and traction pads should be provided at all intersections. These were seen at the larger intersections such as Winter Park Drive and Corrine, yet not at other crossings such as Cole and Corrine.
- 4
- 5 No intersections, or crosswalks clearly marked

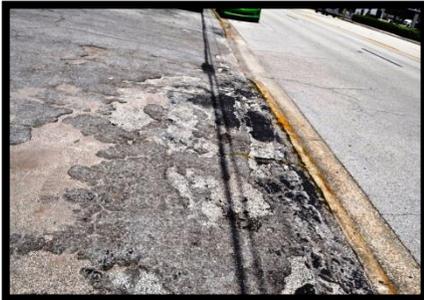
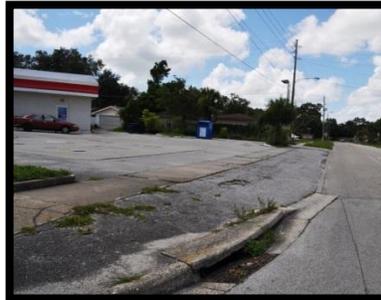
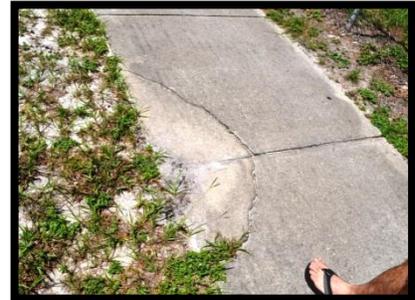
- 1 Major or frequent problems
- 2: The City of Orlando has some major updating to do. All of the sidewalks were at a merely adequate width of 4', which was notably insufficient on the busier Corrine Drive. Passerbys had to awkwardly compete for space and were often wedged between the road and concrete walls or large fences. Wooden and metal fences lining the street were often crooked and in poor condition, factors which could lead to further deterioration. Nearly all of the sidewalks were cracked and/or buckling, especially where large electrical polls were situated; there was even notable infrastructure damage on the curbs themselves. The sidewalks are obviously not routinely cared for as vegetation was growing up through the cracks in numerous, even high-traffic areas. Residential yards often encroached upon public space – we had to walk around

trees, bushes, and landscaping elements in many areas. Although standing water was not evident on this trip, it was noted that there was a lack of stormwater drains in the residential areas on Asbury Ave and Virginia Ave, and it was perceived that this could be a potential hazard.

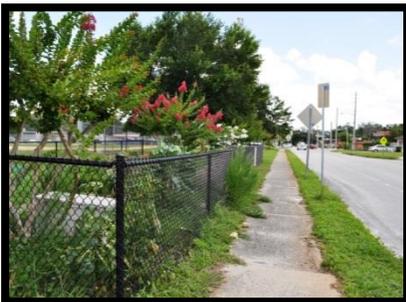
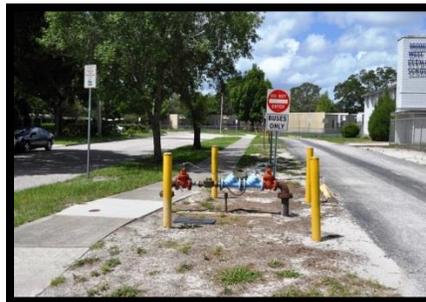
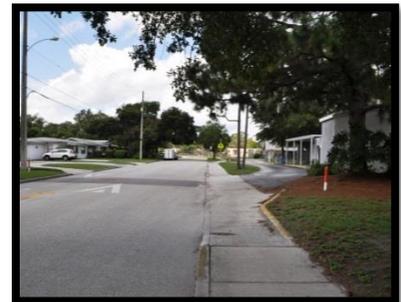
- 1 - No buffer from roadway
- 2
- 3: As noted above, where there was a buffer, it was minimal. Widths of 3 feet were noted near Audubon Park and Brookshire West Elementary along both Winter Park Dr. and Virginia Avenue. There was one stretch on Virginia Ave. where a 5 foot buffer was noted, yet the lack of sidewalks all around led to a noticeable lack of buffer space.
- 4 > 4 feet from roadway
- 5 Not adjacent to roadway

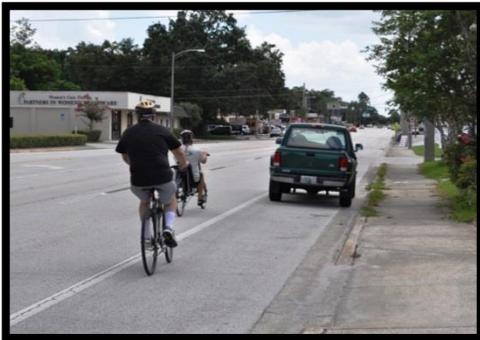
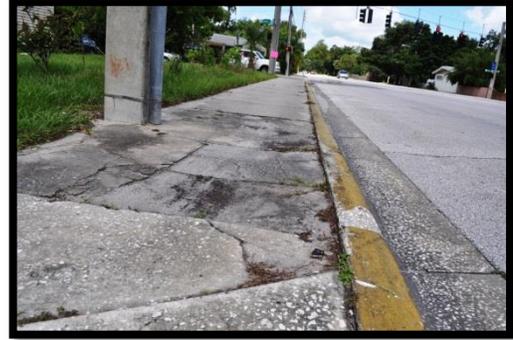
- 1 High conflict potential
- 2:
- 3: Pedestrian visibility on the street was certainly low given both the massive scale of the curb-to-curb width of Corrine Drive (approximately 56') and then the use of provided on-street and parking lot parking. Four lanes of traffic, a turn lane, and on-street parking certainly overwhelm the miniscule 4-5' sidewalk available. When in use, pedestrians are very hard to discern as they are often hidden behind parked cars. A feeling of being insignificant is particularly enhanced as drivers are only able to make eye contact with pedestrians while traveling 20mph or below – the posted speed limit is 35 mph. Intriguingly, bikers seem to have overtaken the unused space provided on the road in the traditional form of on-street parking and where there is no on-street parking, this certainly provides adequate space for cycling use. It is, however, only provided on the south side of the street and poses a danger when bikers have to swing out and around any parked cars there. Corrine in general is a pretty busy thoroughfare, used by many people making their way from downtown and Colonialtown into the neighborhoods of Winter Park and Baldwin Park, with Audubon of course situated in between. Given the availability of high-use facilities such as Redlight Redlight, Sushi Lola, Stardust Café, and even Leu Gardens and the upcoming East End Market, the sidewalk width was severely insufficient to provide safety and reasonable comfort from the traffic close by. This is especially true when one takes into consideration the sidewalk only existing on one side – people walking in groups or in opposite directions have to awkwardly fight for space with

one or more person often ending up in the street. In fact, it was noted that it was terrifying to walk east, with the traffic, as the cars felt incredibly close as they walked by. Even at the posted speed of 35 miles per hour, cars felt to be moving much faster, as there are very little traffic calming efforts to force them to do otherwise. Traffic coming in and out of the shopping centers and gas stations was notably high, a consideration that makes the casual stroll feel unsafe. Where residential homes are situated on Corrine Drive, there was very little obstruction in the form of drive-ways or loading docks. It also appears that large trucks bringing deliveries are meant to use back alleys behind the shopping centers.

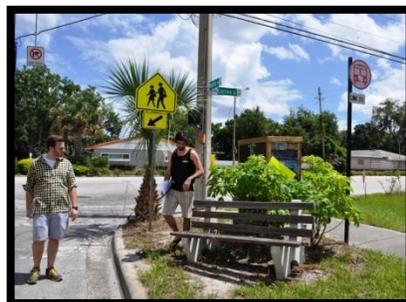
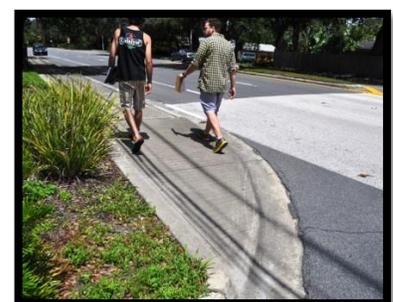
- 1 Crosswalks not present despite major intersections
- 2
- 3: There are adequate crossing light facilities provided at the intersection of Corrine and Winter Park Rd. which allow for sufficient crossing time, as well as at the intersection of Bumby and Corrine. Intersections are clearly marked, although the sidewalk is not very wide, making wait time feel uncomfortable. There is, however, the advantageous addition of a park bench at the corner of Bumby and Corrine just in case someone wants to take a break. As noted above, the sidewalk appears to be wedged into a smaller area at the intersection, providing an inadequate space for any more than one pedestrian to cross. Paint along the entirety of the thoroughfare is in need of an update – and traction pads should be provided at all intersections.
- 4
- 5 No intersections, or crosswalks clearly marked

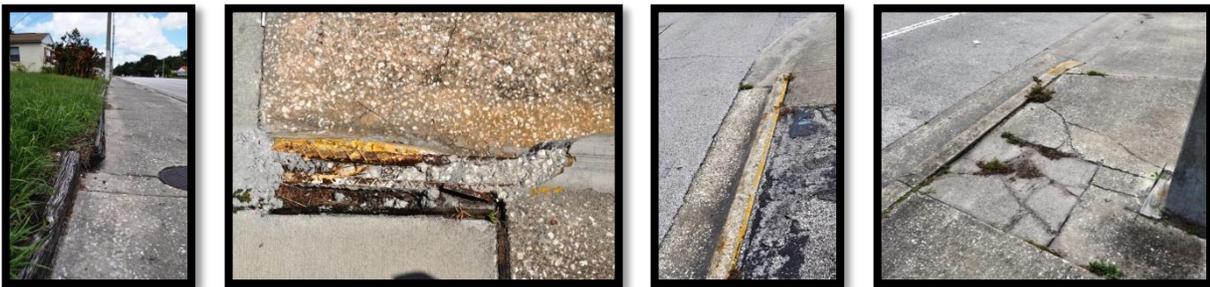
- 1 Major or frequent problems
- 2: The sidewalk facilities all along Corrine Drive were in need of a major update. Many cracks were noted along the way and where large infrastructure was situated on the sidewalk, the sidewalk was buckling certainly under the pressure. Cracks were even noted on the street and on the curb, at one point even some of the metal support rods were jutting up out of the fissures. Cracks were even noted on the sidewalk that fronts the retail space between Christy and Winter Park Ave. and the entire parking lot that acts as an impromptu walking path is in need of being resurfaced. Vegetation was certainly growing up through the cracks along the entirety of the stroll, and resident's yards were spilling out into the sidewalk at many points of contact. There was even one instance in which a homeowner placed their own buffer between their yard and the sidewalk, yet the grass was pushing it out far into the sidewalk; a hazard any pedestrian might trip over if not astutely cognizant. Even the sidewalk at the shopping plaza was cracking in some parts, the remnants not even swept away.
