PEDESTRIAN AUDIT: ½ MILE SEGEMENT ANALYSIS #1

Location: Campus View Drive to Hungerford Prep Elementary School Field via Kennedy Blvd
Date: 7/12/2013

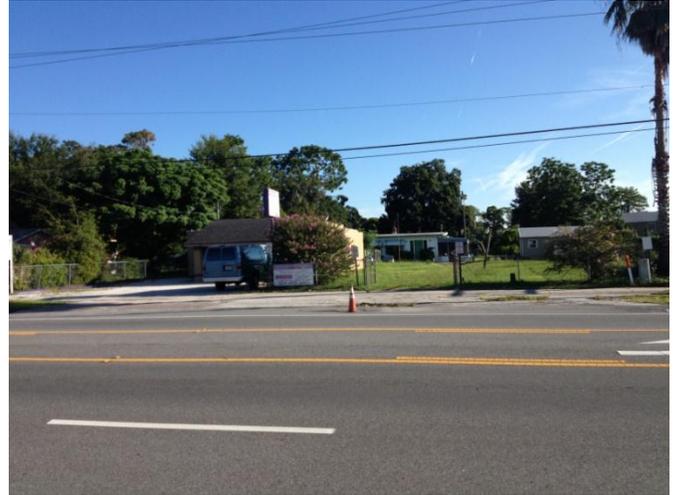
3 Sidewalk on one side of road; minor discontinuities that present no real obstacle to passage

Standing on one sidewalk of Kennedy Blvd observing the sidewalk on the opposite side

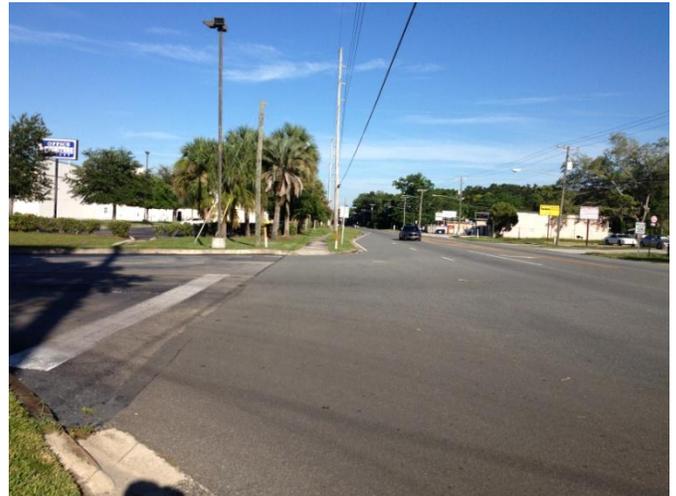
3 Somewhat high conflict potential with high pedestrian visibility

Looking at a parking lot entrance along Kennedy Blvd. - High pedestrian visibility with no tree or sign blockage

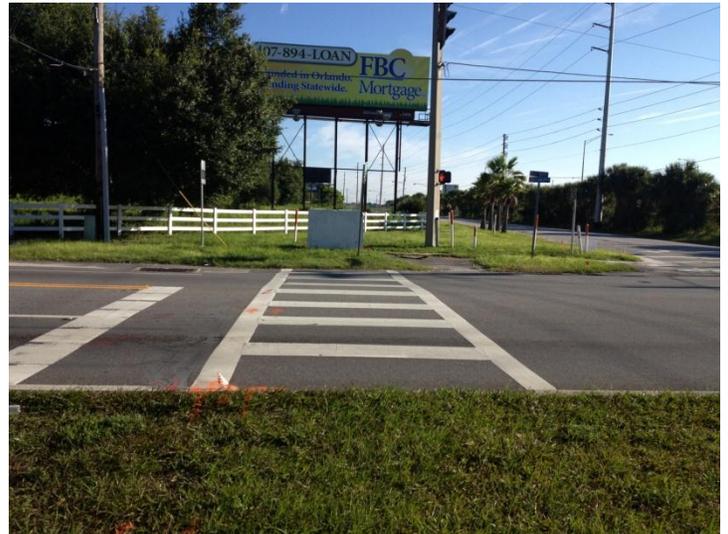
3 Crosswalks present at major crossings near Interstate 4 and at most entrances to shopping parking lots. There is a sidewalk connecting grass to more grass on the opposite side of the street as opposed to connecting sidewalk paths to one-another.

This shows the crosswalk from nowhere to nowhere

The crosswalk on either side of the I-4 overpass is the most dangerous section of this segment. The overpass causes low visibility for automobile drivers as they emerge on the opposite side to another crosswalk. This is also the location of the cross to nowhere shown in a photograph for the Crosswalk section. This crosswalk has only one signage for automobile drivers.

There should be engineering improvements with at least three signs designating the pedestrian crossing zones. There should be additional trees planted to provide a canopy in this open area. The sidewalk would benefit from maintenance to fix cracks and buckling. This strip also does not contain any trash receptacles, leaving trash thrown about. Both a waste and recycling bins would be beneficial in this section.

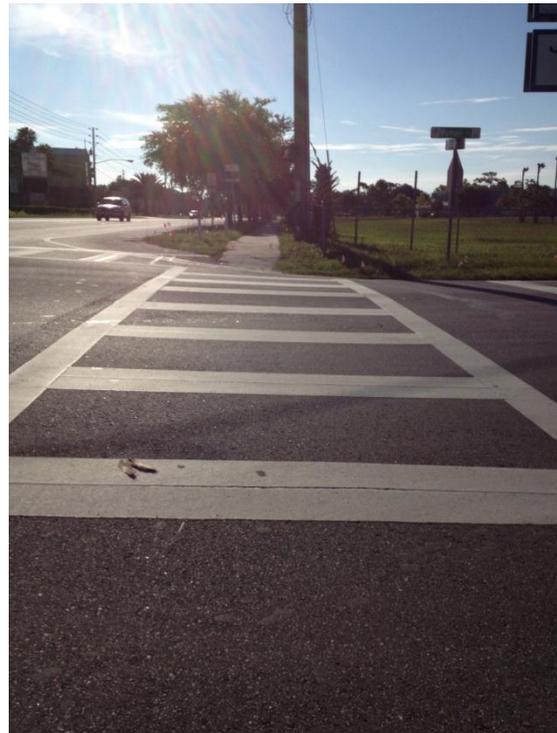
Major intersection has painted crosswalks, but clearly lacks pedestrian signage such as: advance yield warning sign or state law in-street signage to warn drivers

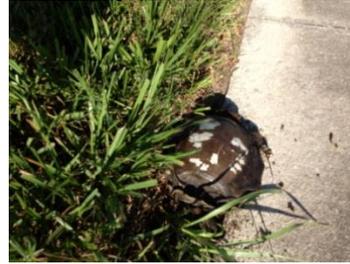
2 Cracking in the sidewalk was apparent. Buckling also occurred with root systems of closely planted trees. There was also a dead animal on the sidewalk.

A dead turtle rotting in the sidewalk of Kennedy Blvd

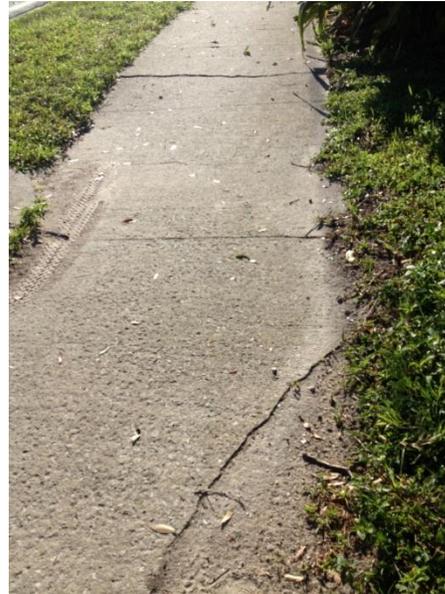
Visible cracking in the sidewalk and caving in of the sidewalk

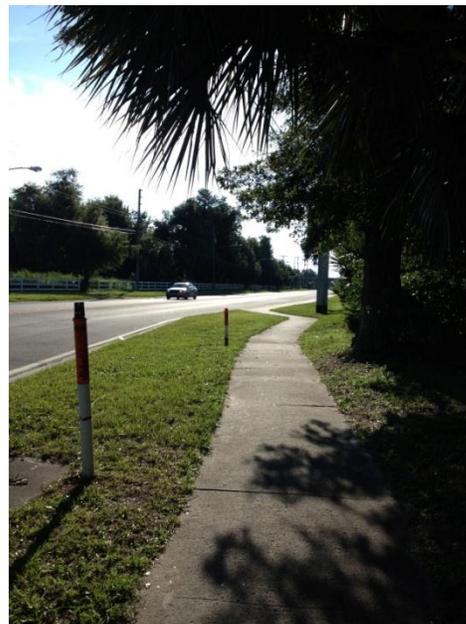
4 > 4 feet from roadway. The majority of this segment had a greater than five foot barrier. One segment had no buffer.

The point at which the 5 foot buffer becomes a 0 ft buffer. Behind where this photo was taken, the buffer increases to 10 ft

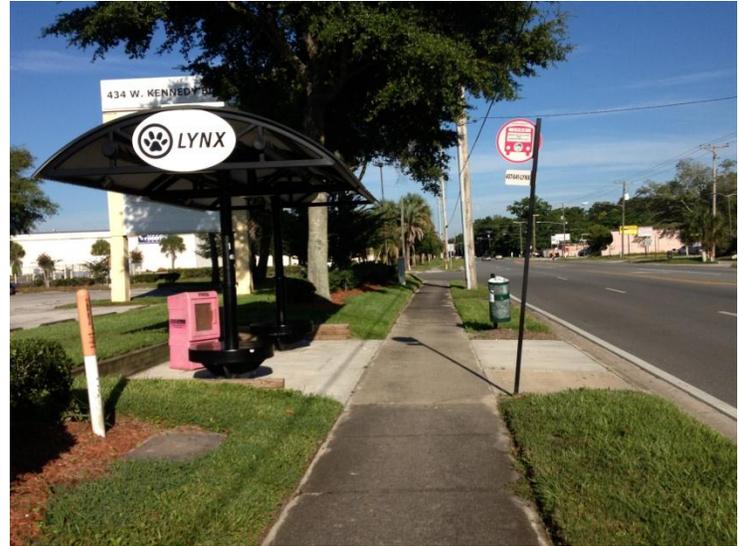
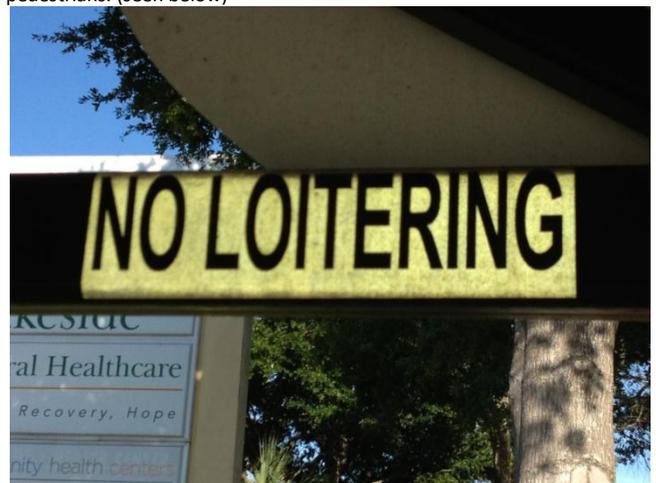
3 The landscaping is not pleasant or unique. The noise pollution is average. There are no aesthetic features to enhance the pedestrian experience beyond benches at the bus stops which also include No Loitering stickers.

This bus stop offers seating, shade, and amenities such as waste receptacles. However there are 2 No Loitering signs posted on the bus stop, creating an uninviting environment for passing pedestrians. (seen below)

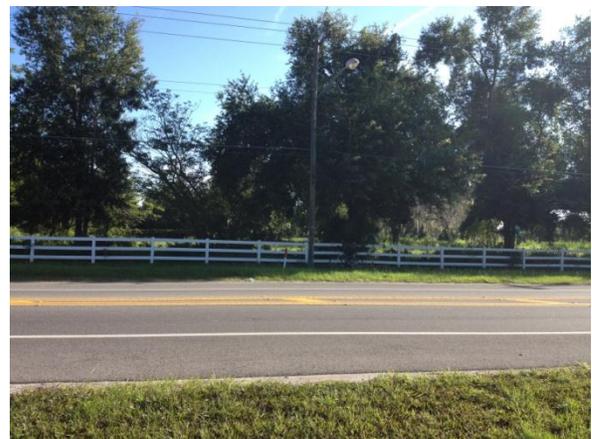
4 One side of the road's sidewalk stays under tree canopy for the majority of the segment. The other side has periodical shaded areas resulting in an above average score

Shows the tree canopy created for the opposite sidewalk on Kennedy Blvd
