PEDESTRIAN AUDIT: ½ MILE SEGEMENT ANALYSIS

Dartmouth Park

Segment 2: ½ Mile Segment Location: New Hampshire Rd - from Dartmouth Park to Rio Grande Drive

Date: July 11, 2011

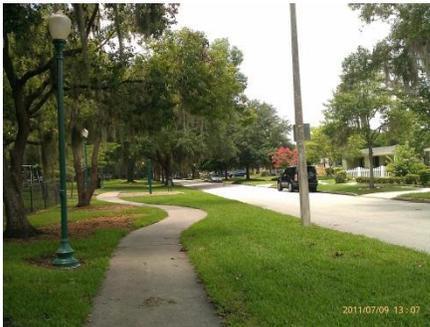
- 1 **Pedestrian Facilities (High):** presence of a suitable walking surface, such as a sidewalk or path.
- 1 No permanent facilities; pedestrians walk in roadway or on dirt path
- 2
- 3 Sidewalk on one side of road; minor discontinuities that present no real obstacle to passage
- 4
- 5 Continuous sidewalk on both sides of road, or completely away from roads

Score = 5, A few streets that were redeveloped in the 1960s-1980s may have missing sidewalk segments or sidewalks on only one-side of the street. However, the entire segment chosen for this exercise had well-maintained four foot wide sidewalks with few pedestrian conflicts on both sides of the street.

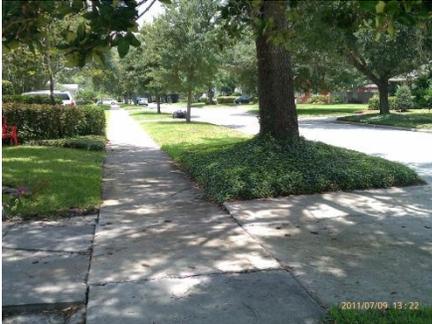
2 Pedestrian Conflicts (High): potential for conflict with motor vehicle traffic due to driveway and loading dock crossings, speed and volume of traffic, large intersections, low pedestrian visibility

Score = 4, Very few conflict points exist but sometimes cars will park across sidewalks that bisect the driveways. This, however, is beyond the design controls of the city and can only be enforced through fines.

- 1 What is the most dangerous location along this segment? *The most dangerous location at this segment is any location where a vehicle is parked in a driveway that is blocking a sidewalk. This forces pedestrians out into the street. Due to the slow moving traffic in this neighborhood it may not be much of an issue but would be in higher speed, higher volume traffic lanes in other locations.*

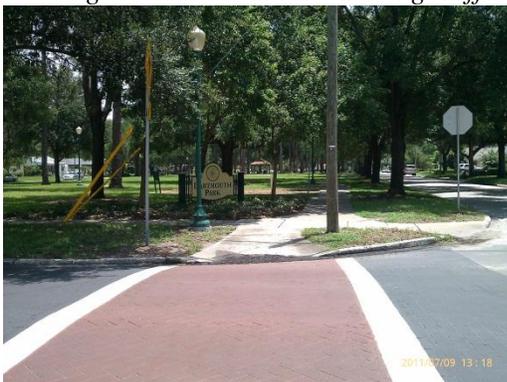
3 Crosswalks (High): presence and visibility of crosswalks on roads intersecting the segment. Traffic signals meet pedestrian needs with separate “walk” lights that provide sufficient crossing time.

Score = 4, Crosswalks are provided across streets that are proximate to the park. However, few crosswalks are provided along the ½ mile segment chosen for this exercise. Since this is a residential neighborhood with slow moving traffic and four-way stops, crosswalks may not be necessary.

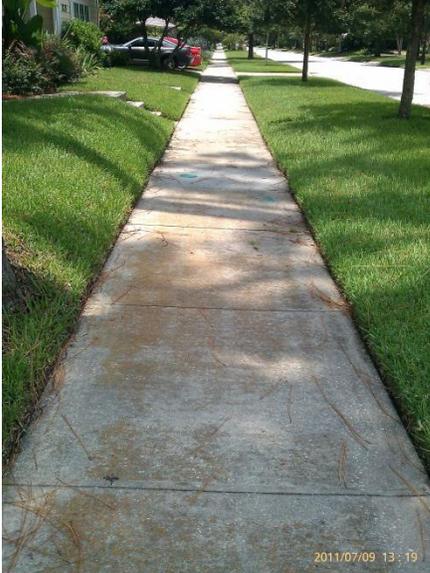
4 Maintenance (Medium): cracking, buckling, overgrown vegetation, standing water, etc. on or near walking path. Does not include temporary deficiencies likely to soon be resolved (e.g. tall grass)

Score = 5, the sidewalks along this segment were in excellent condition with level surfaces and very little cracking or buckling.

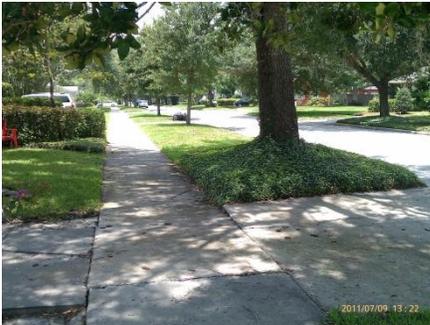
5 Buffer (Medium): space separating path from adjacent roadway

Score = 4, A grass and canopy tree-lined buffer that is approximately 10 feet wide exists between the sidewalk and street.

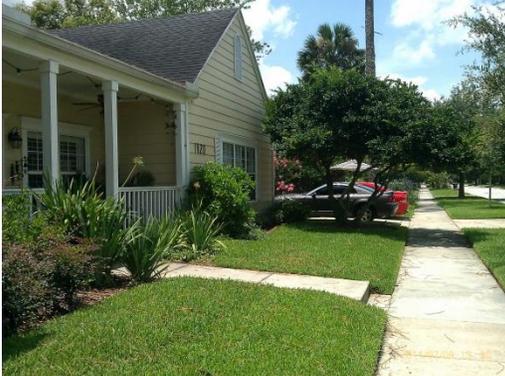
6 Aesthetics (Medium): includes proximity of construction zones, fences, buildings, noise, pollution, quality of landscaping, and pedestrian-oriented features, such as benches and water fountains

Score = 4, this 1/2 mile segment consists of single-family residential. The single-family homes along this segment often have large front porches and pleasant landscaped front yards oriented towards the sidewalks which provides for a pleasant walking atmosphere.

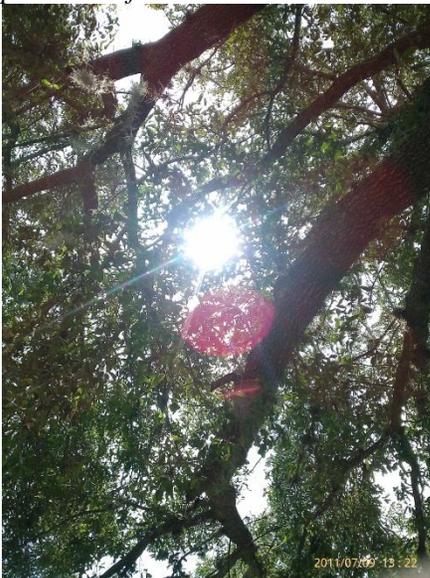
7 Shade (Medium): amount of shade, accounting for different times of day

Score = 5, The sidewalks along this segment are lined with a mature shade tree canopy providing protection from the hot Florida summer sun.
