## PEDESTRIAN AUDIT: ½ MILE SEGMENT ANALYSIS

**Segment Location:** Winter Park Housing Authority to Eatonville Community Center

**Date:** Sunday, July 8, 2012

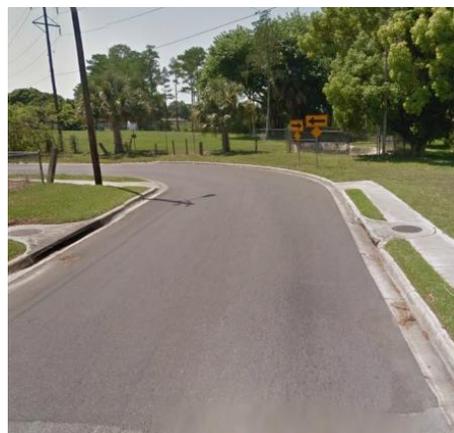
**1. Pedestrian Facilities (High):** presence of a suitable walking surface, such as a sidewalk or path.

**2** While there is a sidewalk on most of this route, there are two crucial locations where the sidewalk and pedestrian crossing are very dangerously placed. There is also a segment of this route where there is no sidewalk and the path where pedestrians can walk is overgrown.

Adding a sidewalk all along Monroe and a signaled crosswalk marking pedestrian use at West and Fitzgerald and Jonotey and Monroe would make this segment more appropriate for pedestrian use.

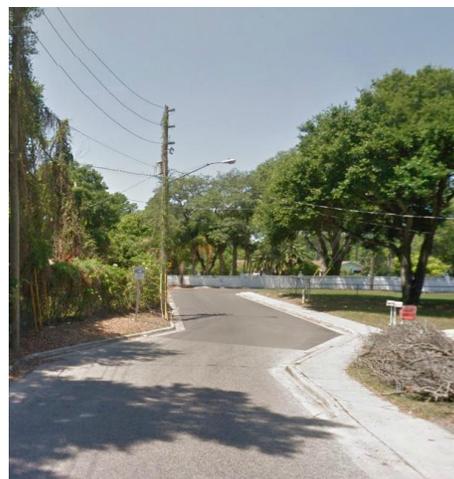
**2. Pedestrian Conflicts (High):** potential for conflict with motor vehicle traffic due to driveway and loading dock crossings, speed and volume of traffic, large intersections, low pedestrian visibility.

**1** High conflict potential: Though the traffic volume is low, there are two significant pedestrian conflicts. These conflict points are crosswalks at very sharp turns and curves in the road where there is low pedestrian visibility and no buffer between the street and the sidewalk even before the crossing.

The curves where West becomes Fitzgerald and Jonotey becomes Monroe are the most dangerous locations along this segment.

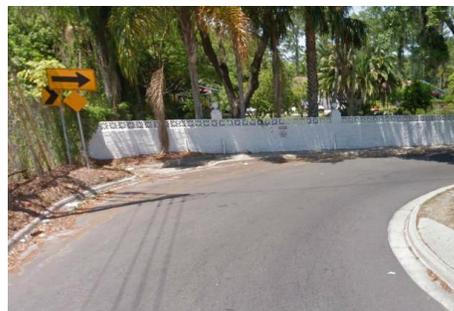
**3. Crosswalks (High):** presence and visibility of crosswalks on roads intersecting the segment. Traffic signals meet pedestrian needs with separate 'walk' lights that provide sufficient crossing time.

**2** Because of the low traffic flow there is not a need for marked crosswalks or signals at all of the intersections on the route, however at the turns where the sidewalk switches sides of the thoroughfare, there is a definite need for them.

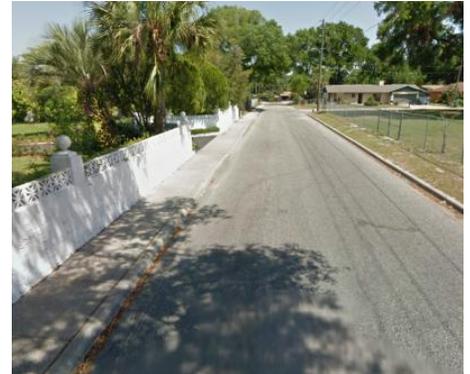
4. Maintenance (Medium): cracking, buckling, overgrown vegetation, standing water, etc. on or near walking path. Does not include temporary deficiencies likely to soon be resolved (e.g. tall grass).

**3 There is some overgrown vegetation, but there are less empty lots on this route and the residential lots are better kept.**

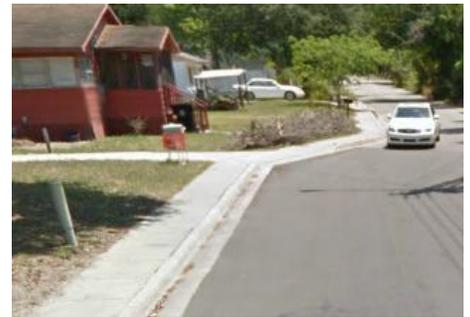
5. Buffer (Medium): space separating path from adjacent roadway.

**2 The buffer on this route is very minimal and at times the walkway is too close to the street so that the pedestrian feels incredibly unsafe.**

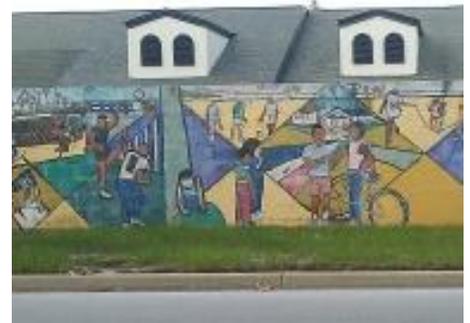
6. Aesthetics (Medium): includes proximity of construction zones, fences, buildings, noise pollution, quality of landscaping, and pedestrian-oriented features, such as benches and water fountains.

**3 Landscaping on this route could be much better, however there is very interesting art on this pedestrian path, ranging from work done by young children to homages to world-famous graffiti artists**

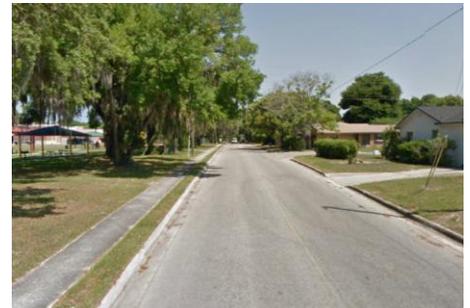
7. Shade (Medium): amount of shade, accounting for different times of day.

**3 There is a fair amount of shade, however for Florida's summer heat, it is not enough**
