PEDESTRIAN AUDIT: ½ MILE SEGEMENT ANALYSIS

Segment Location: North Orange Avenue – Gaston Edwards Park Date: July 10, 2011

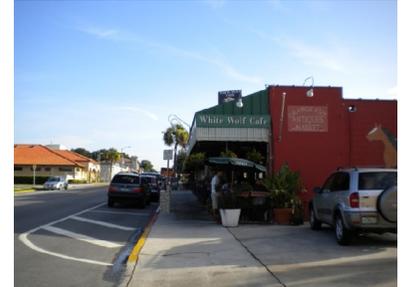
Score 4

A portion of the ½ mile walk does not have a sidewalk on both sides of the street. Overall the walk was comfortable and understandable.

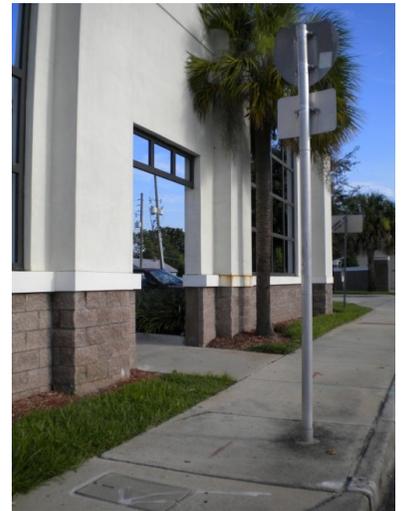
Score 5

This opening in the architectural feature around the convenience store is an example of how the walkability of the corridor is integrated into the uses and function of the spaces.

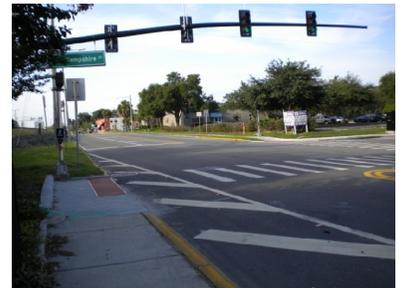
Score 5

Major intersections signalized and marked, textured cross walks provide visual and tactile indication of pedestrian movement for vehicular. Audio crossings provided along North Orange Avenue.

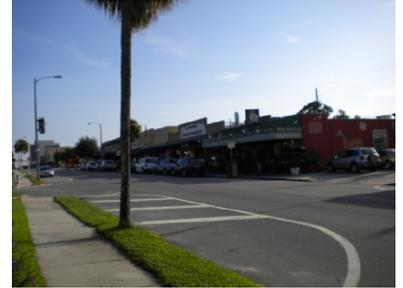
Score 5

Well maintained, intersections recently updated for accessibility

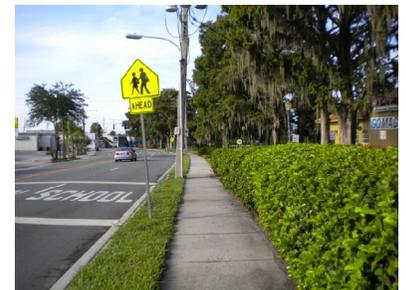
Score 3

Areas of the route are close to the roadway, however, on most portions, the sidewalks were buffered with parallel parking spaces

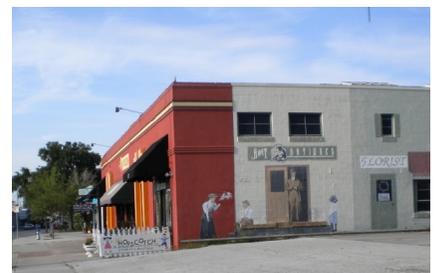
Score 3

Casual, charming details along the route add to the visual interest of the area. Additional attention to continuous landscaping and site features such as benches is needed.

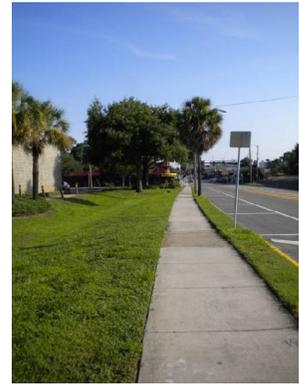
Score 2

Shade is lacking throughout several segments of the walk even with the availability of land area to add canopy trees.

Portions of the segment have little shade, and portions of the sidewalk are too narrow for more than one person. A sidewalk and pedestrian easement to the City would allow for planting of shade trees and widening of the pathway. Potted plants and larger canopies or awnings on commercial structures would help provide relief from the Florida sun and rain.
