# PEDESTRIAN AUDIT: ½ MILE SEGMENT ANALYSIS

Location: Einstein Bros Bagels at 2817 Edgewater Dr, Orlando, FL to Princeton Park

Date: July 21, 2011 By John Chenoweth

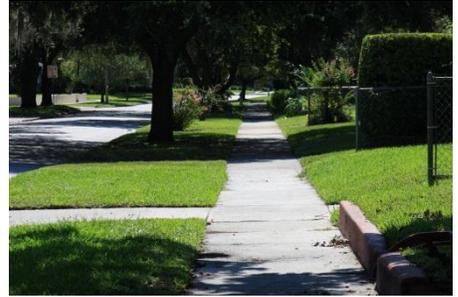
**1. Pedestrian Facilities (High):** presence of a suitable walking surface, such as a sidewalk or path.

**5 Continuous sidewalks on both sides of road, or completely away from roads**

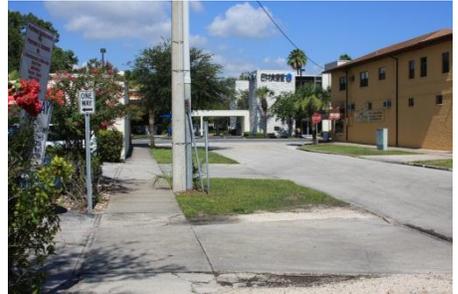
**2. Pedestrian Conflicts (High):** potential for conflict with motor vehicle traffic due to driveway and loading dock crossings, speed and volume of traffic, large intersections, low pedestrian visibility.

**4 Many driveways, but only 1 road crossing that had a stop sign.**

The most dangerous location is crossing the business parking lot entrance after turning on to Rugby Street. While observing traffic entering the parking lot, drivers appear distracted looking for parking spaces and talking on the phone. Drivers do not appear to be aware of the sidewalk or pedestrian traffic.

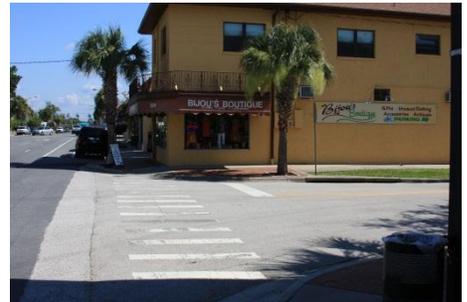
**3. Crosswalks (High):** presence and visibility of crosswalks on roads intersecting the segment. Traffic signals meet pedestrian needs with separate 'walk' lights that provide sufficient crossing time.

**4 Crosswalks and crossing signals do exist. There are no marked cross walks in the residential neighborhood, but all intersections do have stop signs.**

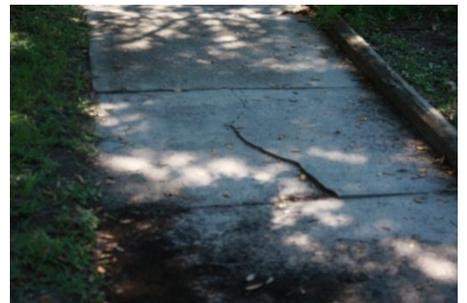
**4. Maintenance (Medium):** cracking, buckling, overgrown vegetation, standing water, etc. on or near walking path. Does not include temporary deficiencies likely to soon be resolved (e.g. tall grass).

**4 Several areas are raised due to tree growth and this could present a hazard to joggers, and walkers at night.**

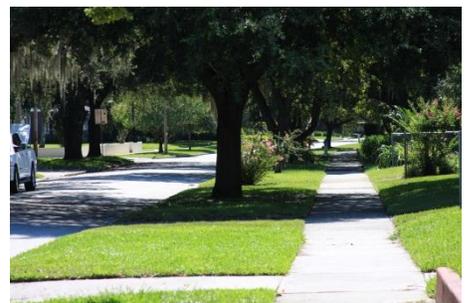
**5. Buffer (Medium):** space separating path from adjacent roadway.

**5 Along Edgewater Drive the sidewalk is buffered by parallel parking. There is a 12 foot buffers between the sidewalk and the street during the residential segment.**

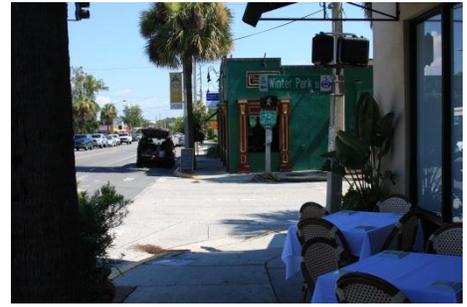
**6. Aesthetics (Medium):** includes proximity of construction zones, fences, buildings, noise pollution, quality of landscaping, and pedestrian-oriented features, such as benches and water fountains.

**3** The first part of the walk along Edgewater Drive goes takes pedestrians past some businesses. Some of the sidewalks are narrow and difficult to walk side by side. The segment through the College Park residential neighborhood is quiet and peaceful, but lacks items to keep the attention of pedestrians

Walking past a few shops and boutiques along Edgewater drive was a pleasant experience and shows what planners should incorporate into a mixed use area. The section of the walk through the residential neighborhood became monotonous with little to look at and a repetition of single family houses.

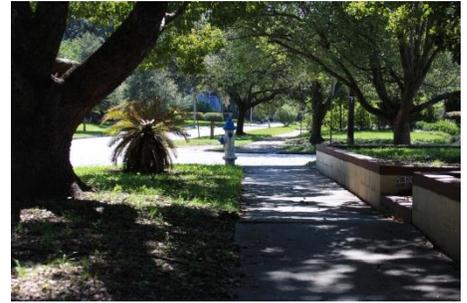
**7. Shade (Medium):** amount of shade, accounting for different times of day.

**5** Full shade: The street is well shaded for most of the walk.
