PEDESTRIAN AUDIT: ½ MILE SEGMENT ANALYSIS:

Location: Whole Foods at 1989 Aloma Ave Winter Park, FL 32792 to Cady Way Park

Date: July 9, 2011 By John Chenoweth

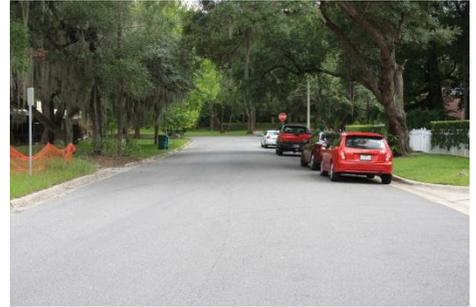
1. Pedestrian Facilities (High): presence of a suitable walking surface, such as a sidewalk or path.

- 1** No permanent facilities; pedestrians walk in roadway or on dirt path
- 2
- 3 Sidewalk on one side of road; minor discontinuities that present no real obstacle to passage
- 4
5. Continuous sidewalk on both sides of road, or completely away from roads

- 1. Add a pedestrian signal to cross Aloma.
- 2. Add sidewalks where they do not exist.

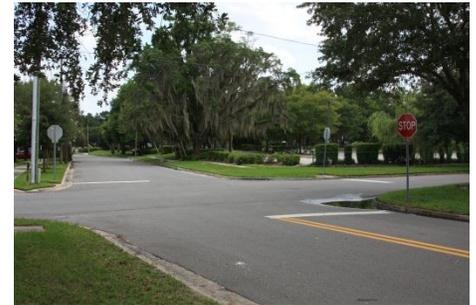
2. Pedestrian Conflicts (High): potential for conflict with motor vehicle traffic due to driveway and loading dock crossings, speed and volume of traffic, large intersections, low pedestrian visibility.

- 1** High conflict potential. Portions of the walk do not have sidewalks and force pedestrian into the road.
- 2
- 3
- 4
- 5 Low conflict potential

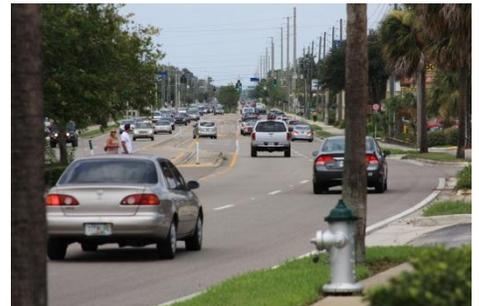
3. Crosswalks (High): presence and visibility of crosswalks on roads intersecting the segment. Traffic signals meet pedestrian needs with separate 'walk' lights that provide sufficient crossing time.

- 1** Crosswalks not present despite major intersections and destinations on www.walkscore.com
- 2
- 3
- 4
- 5 No intersections, or crosswalks clearly marked

The most dangerous part of this walk was the crossing of Aloma, also called state road 426. There are no crosswalks in the area and crossing at a light will add ½ mile to the walk. In addition cars travel without acknowledgment of pedestrians as was observed as a couple attempted to cross the road. A close second were the sections without sidewalks despite an abundance of parking.

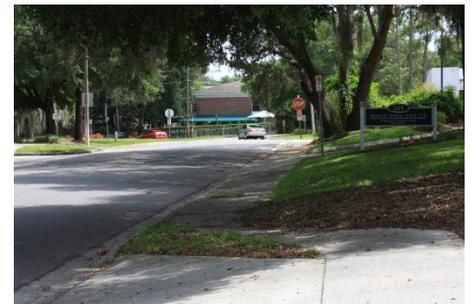
4. Maintenance (Medium): cracking, buckling, overgrown vegetation, standing water, etc. on or near walking path. Does not include temporary deficiencies likely to soon be resolved (e.g. tall grass).

- 1 Major or frequent problems
- 2
- 3
- 4** Smooth sidewalks when present, but general clean up to remove tree debris is required.
- 5 No problems.

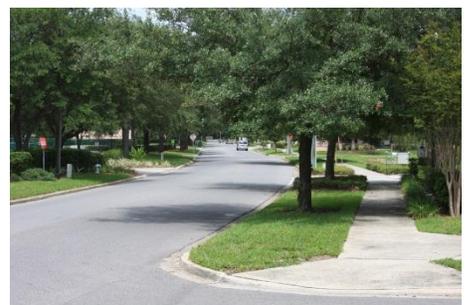
5. Buffer (Medium): space separating path from adjacent roadway.

- 1 No buffer from roadway
- 2** When present they included some trees for separation from traffic.
- 3
- 4 > 4 feet from roadway.
- 5.

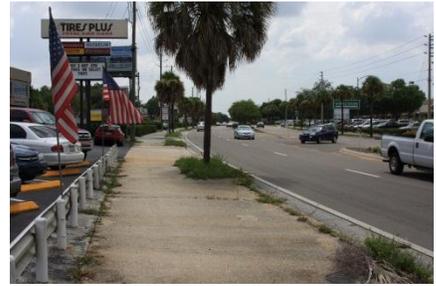
6. Aesthetics (Medium): includes proximity of construction zones, fences, buildings, noise pollution, quality of landscaping, and pedestrian-oriented features, such as benches and water fountains.

1 Uninviting. From this starting point to the destination, while listed on www.walksocres.com is very uninviting and should not be considered a pedestrian walk.

The most unpleasant element of this walk is the portion along Aloma that lacks any consideration for pedestrians and walks in front of an auto repair business.

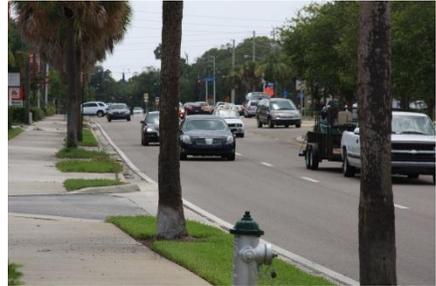
7. Shade (Medium): amount of shade, accounting for different times of day.

3 The portions away from Aloma had good shade coverage, but along Aloma, there was no shade coverage.
