## PEDESTRIAN AUDIT:

### EATONVILLE TOWN HALL URBAN PLAZA

Date completed: July 7, 2012

Eatonville Town Hall Urban Plaza along sidewalk beside Kennedy Blvd. to Macedonia Missionary Baptist Church.

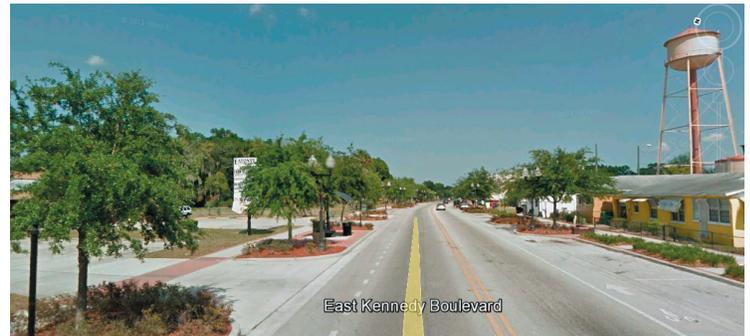
Sidewalks on both sides of road. Multiple curb cuts create potential future conflicts.

There is a 5 foot side walk located on both sides of Kennedy Blvd. The sidewalk is concrete with brick at the intersections.

Currently there is minimum conflict with motor vehicle traffic, but potential problems may exist with future with development of the area. Many curb cuts exist on the south side of Kennedy Blvd that lead to undeveloped lots. As those lots get developed, increased conflicts will arise. This issue has been addressed by increasing the quality of the material (brick) at the conflict points to give priority to the pedestrian.

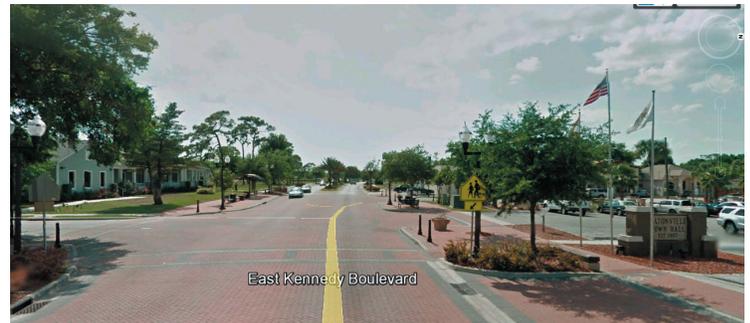
Crosswalks are bricked and signed.

Brick crosswalks are at both important locations of the pedestrian walk shed. No traffic signals currently exist. Most motorists will slow and stop for pedestrians therefore cross signals are unnecessary at this point. Yellow pedestrian crossing signs exist at each of the crosswalks.

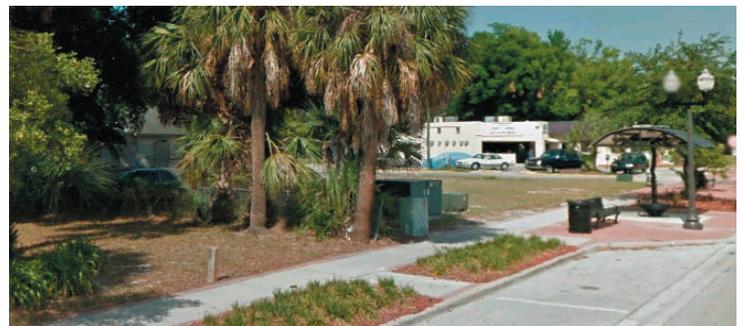
Public area well maintained, private area lacking order.

The concrete and brick sidewalk are in great condition and the landscaping had been recently updated. The surrounding empty lots give an unkempt feeling to the area.

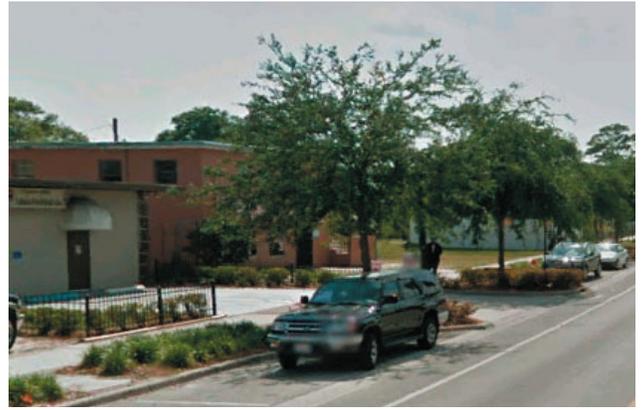
Landscaping, parking and bike lanes buffer the pedestrians from motorists

The space separating the sidewalk from the roadway is ideal. Next to the sidewalk is a landscape buffer. Then there is on-street parking with landscaped bulb outs. The final separation is bike lanes.

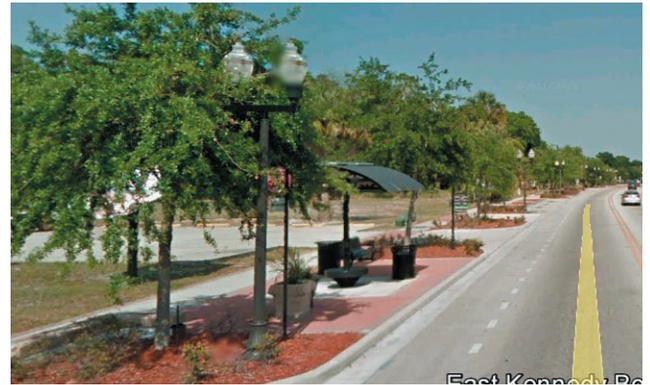
Public facilities have unappealing empty lot backdrop.

The public pedestrian space is provided has ample facilities the surrounding area decreases the aesthetic appeal. The public space contains benches, trash cans, shade cover structures, quality hardscape materials. The area is lacking vertical building enclosure and a disconnect exists between much of the existing buildings. The vertical building enclosure can be resolved with development to the area. The disconnection between existing buildings and the public pedestrian space may be resolved with inventive local art.

3. Improvements to this area for pedestrian use could include economic incentives to encourage development and the encouragement of more local structural art to connect the public space to the existing private spaces.

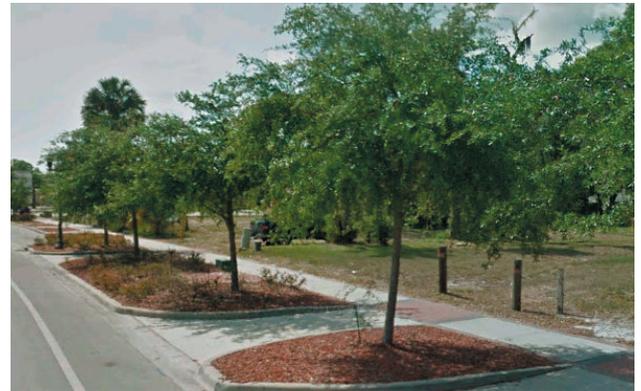
Oak growth will provide ample shade.

The area is well shaded for consideration of the hot Florida sun. The sidewalks are lined with oak trees about 40 feet apart. The center of Kennedy Blvd has a landscaped median with large Canary Island Date Palms. Plus the bus stops pleasing shade structures. The oaks need more time to mature to provide full shade coverage.
