PEDESTRIAN AUDIT: ½ MILE SEGEMENT ANALYSIS

Segment Location: Virginia Avenue – Gaston Edwards Park Date: July 10, 2011

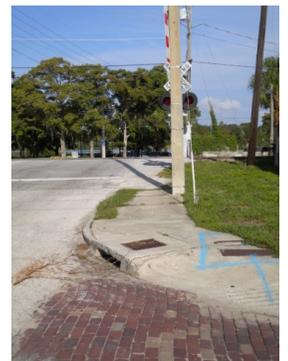
Score 4

This railroad crossing presents potential for pedestrian conflict. The sidewalk stops without any element to alert pedestrians or offer alternative routes. This is the only area of conflict along the route.
