AUDUBON PARK SITE ANALYSIS

PEDESTRIAN AUDIT: ½ MILE SEGEMENT ANALYSIS *from* AUDUBON PARK

Segment Location: Audubon Park – From Corrine Drive, by the Audubon Park Baseball Fields, by Brookshire West Elementary on Winter Park Drive/Virginia Avenue, down Asbury Avenue, and back to Corrine Drive via Cole Road and Christy Avenue

Date: July 6, 2013

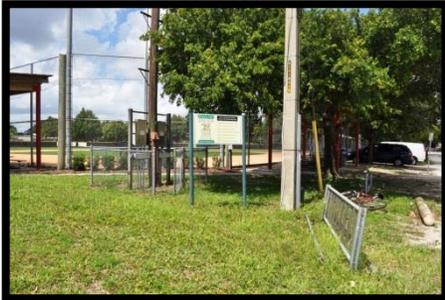
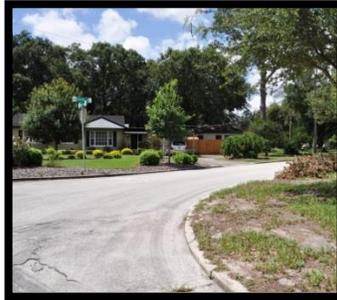
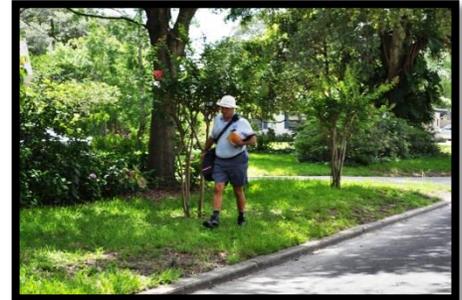
- 1 Uninviting
- 2
- 3: Once off of Corrine Drive, the residential areas of Audubon Park were noticeably peaceful and rather pleasant. It provided a nice space for a casual stroll, free from construction and/or evident noise pollution. Individuals appear to care for their lawns and provide variations of landscaping elements...trees often provided some much needed shade. In fact, despite my apparent harsh criticism, if taken holistically this was certainly an inviting walk I would partake in again. It should be noted, however that the facilities for bike parking and/or seating at

Audubon Park were severely lacking. Bike racks were situated haphazardly and were noticeably an afterthought, sadly in areas where there was notably high bike use. The entrance itself was even uninviting, with a rather small, lackluster sign, and/or unkempt sidewalks; in fact, large telephone poles seemed to be the more predominant feature. There was a small community garden at Audubon Park, but there was no seating provided to participate in this activity, nor a sign to clarify its existence. Also noticeable was the large exposed infrastructure in the form of water lines situated monumentally at the entrance of Brookshire West Elementary.

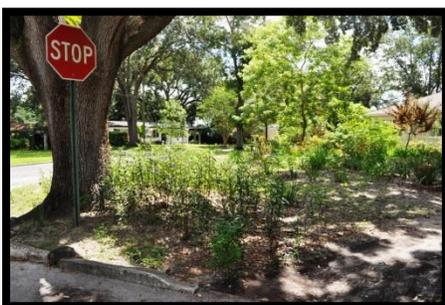
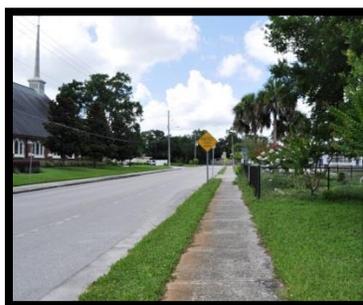
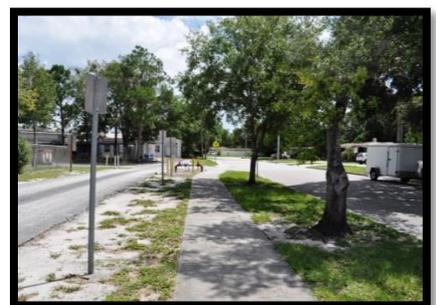
- 1 No shade
- 2
- 3: Shade, like the sidewalk, was intermittent along the walk. Although vegetation was abundant in the residential areas, some of the streets were too wide for the trees to provide an adequate canopy for us to appreciate the shade. Where road widths were more constricted, better shade was provided.
- 4
- 5 Full shade

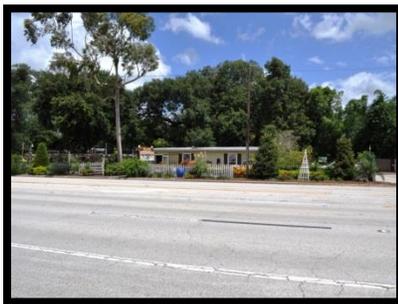
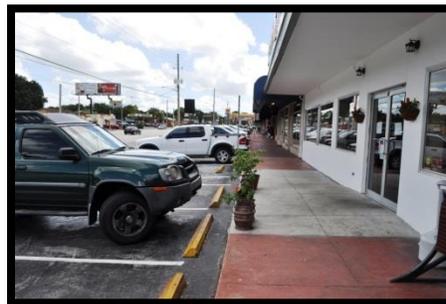
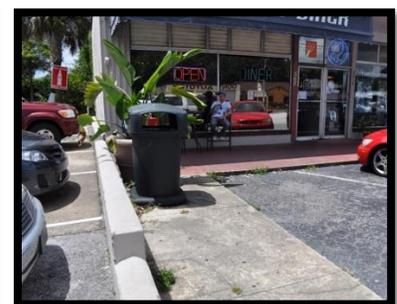
1. Pedestrian Facilities (High): presence of a suitable walking surface, such as a sidewalk or path.
 - 1 No permanent facilities; pedestrians walk in roadway or on dirt path
 - 2: Along the stretch of Corrine between N Bumby and Avenue, ending at Winter Park Drive, the sidewalk only exists on the south side of the street. Although it exists continuously along this strip, it is no more than 4' wide and any street furniture and/or infrastructure takes up more available space, forcing pedestrians to careen into the street in order to pass. It is noted that although there is no traditional bumper situated between the curb and the sidewalk,

there is approximately 8' of buffer provided by the available on-street parking which appears to be only sporadically used. There is the perception that part of the street does not contain sidewalks in front of the retail space between Christy Ave. and Winter Park Drive, yet one is meant to carry on on the parallel sidewalk provided right in front of the shops rather than along the street. This sidewalk is, however, hidden between two rows of parking and it is not clearly defined as to when one is supposed to make the switch from roadside to store front. This slight change in direction was noted on the map above, and is worthy of note as it creates an active storefront landscape. In front of the stores, the sidewalk is painted a noticeably wider at approximately 10'. In some instances, restaurants had outdoor seating provided. This, however, is an obstruction for the regular passerby.

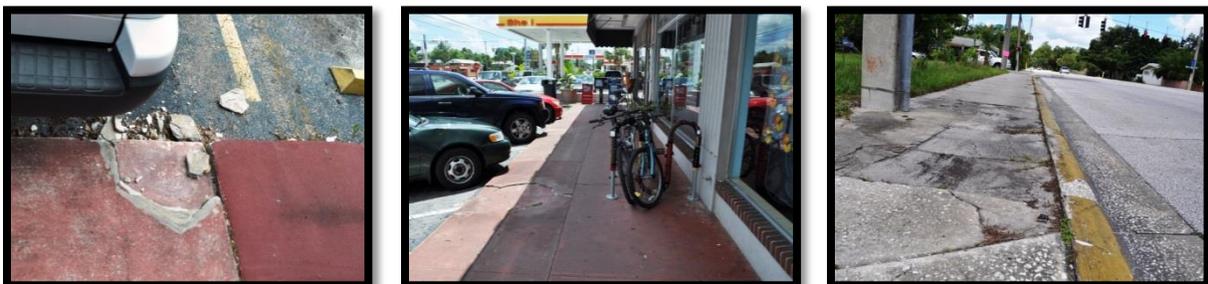
- 1 - No buffer from roadway
- 2:
- 3: Really there was no discerned constructed buffer between the sidewalk and the flow of traffic, yet there was an extemporized buffer provided along Corrine in the form of unused on-street parking. This did provide an element of perceived safety along the strip, especially given the fact that even the curb was noticeably constricted in comparison to the norm – it only stood 8" wide. In the shopping plaza, there was certainly no buffer provided between parked cars and frontscape. Some of the cars' bumpers even hung over into the sidewalk provided.
- 4 > 4 feet from roadway
- 5 Not adjacent to roadway

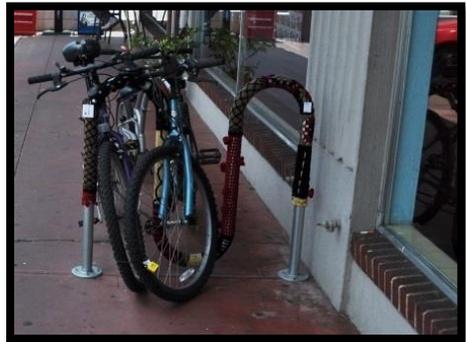
- 1 Uninviting
- 2:
- 3: If focusing just on the streetscape itself, there is very little of note to find aesthetically pleasing, however local citizens are seeming to reclaim portions of the roadway, adding kitschy, makeshift chairs at Lynx bus stops and hand-knit “socks” on the bike racks. Some store owners are even utilizing the sidewalk space to add some much-needed landscaping. There are also hand-painted signs throughout the entirety of Audubon Park, an emblem of pride in the garden community. Certain retail spaces are notably well-taken care of, including Palmer’s landscaping and Stardust Café, yet the walkability which surrounds it provides little sense of invitation. The street was notably active and thriving with many people riding and/or walking to worthwhile restaurant and retail venues. There was in fact very little noise pollution despite the heavy traffic, just more or less a sense of claustrophobia on the sidewalk itself. I know that there is a grassroots community organization advocating for the revitalization of their streetscape called the Calm Corrine Coalition. The growing numbers of people participating within it further proves the communal love felt for the space.

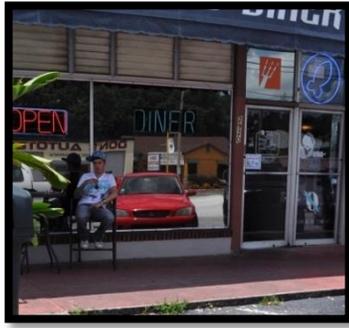
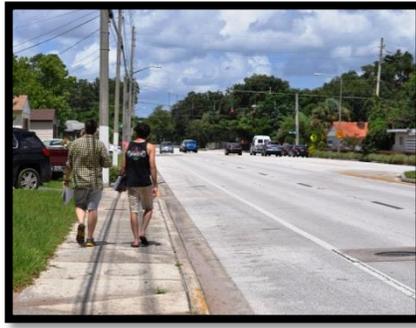
- 1 No shade
- 2: This was perhaps the biggest deterrent from wanting to walk along Corrine drive. There was in fact very little shade to shield pedestrians from the heat, which was certainly a nuisance on a hot summer day. Trees provided were few and far between and most were not tall enough to provide adequate shade – we often even had to move out of the way in order to not walk into them. Even at different times of day, the tree canopy could never provide enough shade over wide Corrine Drive. There was however, shade provided in the form of awnings over store fronts which was certainly a welcome attribute after walking in the heat for so long.
- 3
- 4
- 5 Full shade
