Pedestrian Audit: 1/2 Mile Segment Analysis

Minnehaha Park

Location: 1011 East Horatio Avenue
 Maitland, Florida
 7 Acres

Pedestrian Audit:

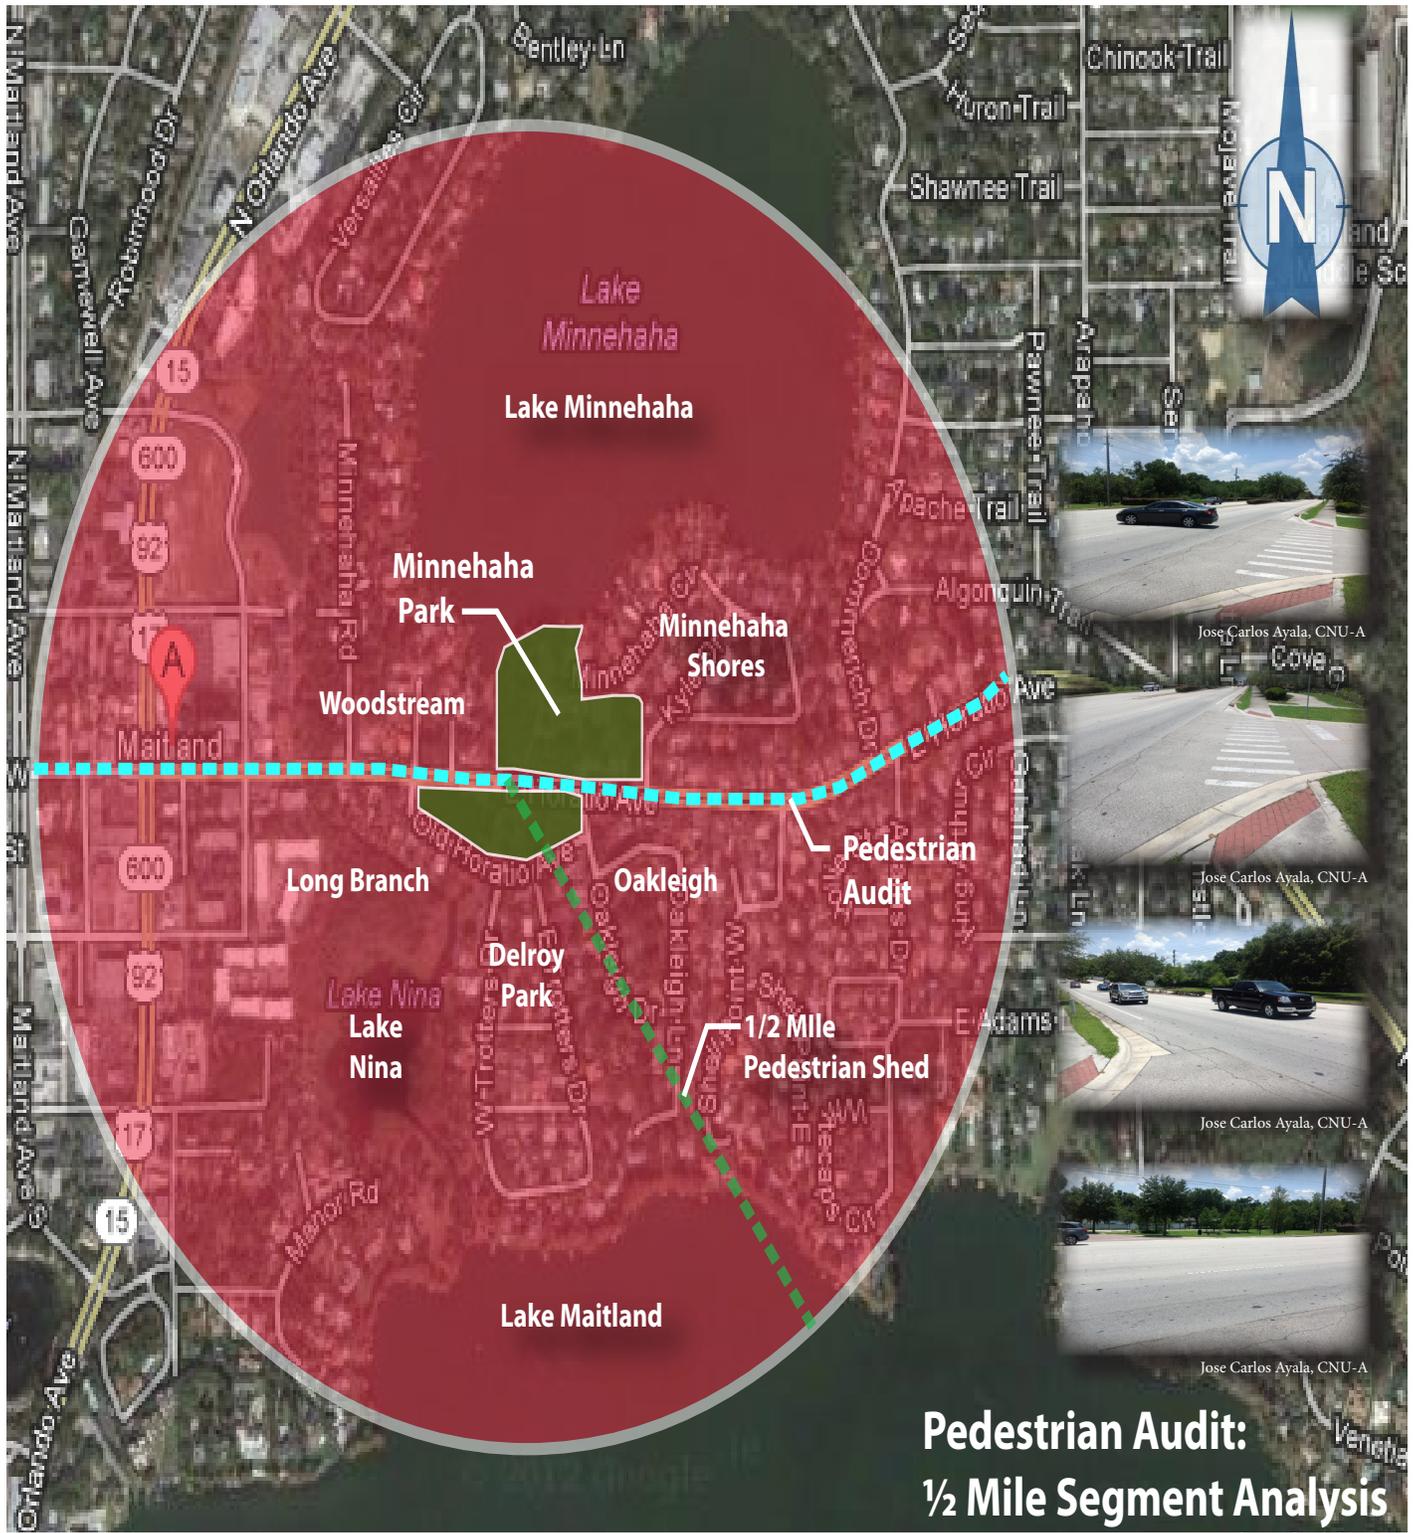
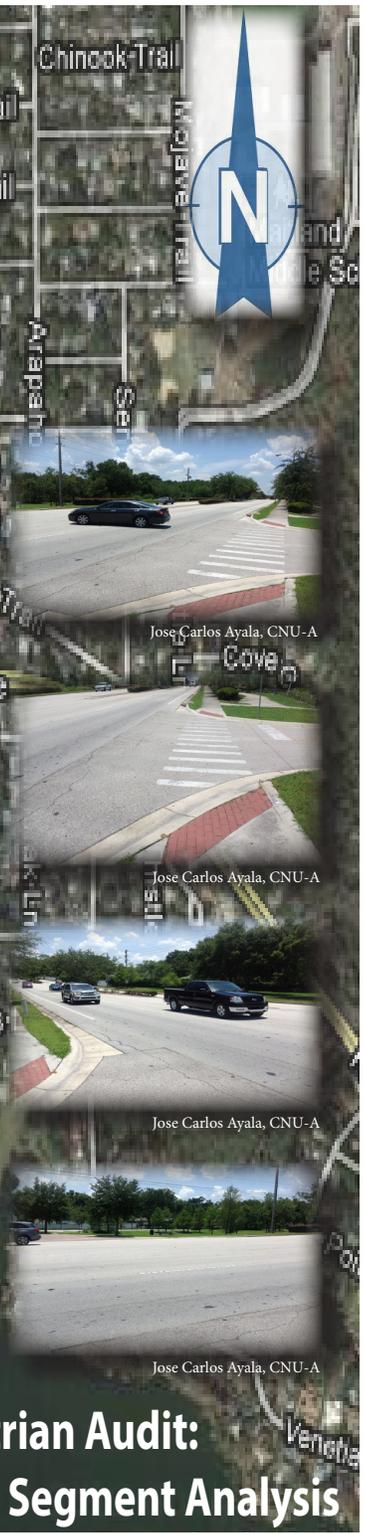
Roadway Sidewalk
-

>5' Multi-Purposed Sidewalk (Concrete or Asphalt)
-

>5' Park Conc. Sidewalk
-

>5' Wood Boardwalk
-

Mulched Path
